# Recreational Use Attainability Analysis for South Lilly Creek (0409B) in the Cypress Creek River Basin

Prepared for:  
Texas State Soil and Water Conservation Board  
Project 16-60

Texas Institute for Applied Environmental Research  
Tarleton State University  
Stephenville, Texas

TR1612

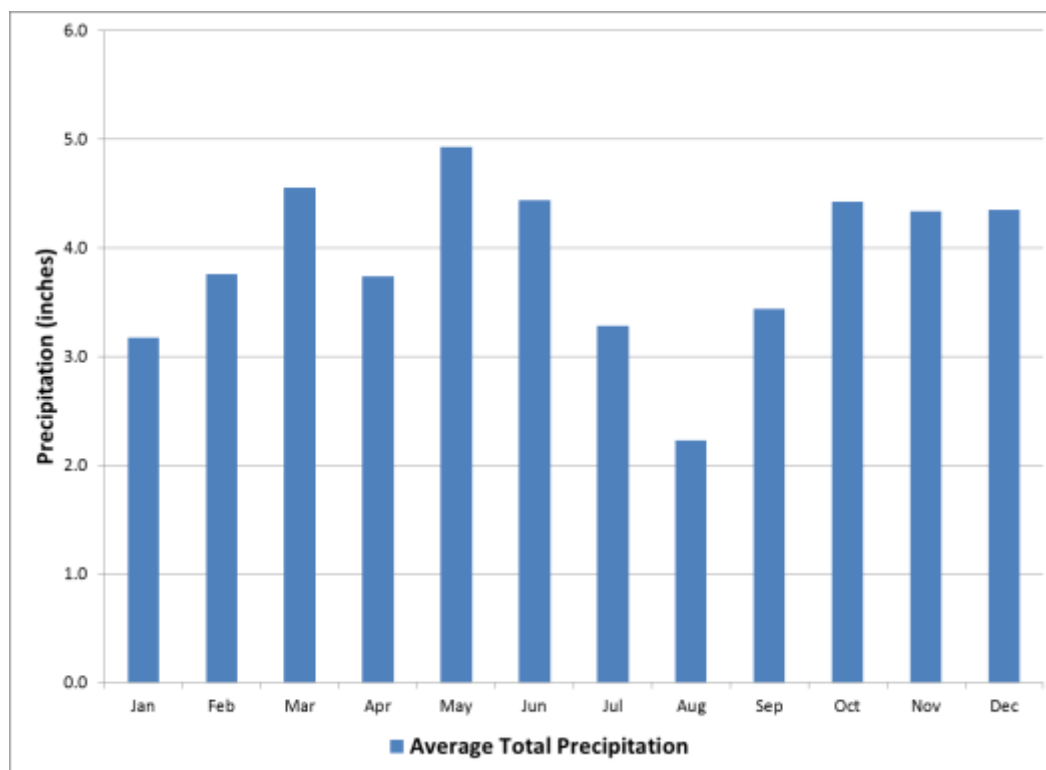
**Figure 3.1** Monthly average precipitation for Pittsburg, Texas.

Source: NOAA (2015) based on data for 1974-2015.

Annual precipitation for the South Lilly Creek watershed was based on data obtained from the National Oceanic and Atmospheric Administration's website (NOAA, 2015) for Pittsburg, Texas. It is important to note that Pittsburg is not within the South Lilly Creek watershed boundaries, but is the nearest town. Because there are no cities within the watershed, the historical data for Pittsburg was used. Normal precipitation (1974-2015) for Pittsburg, Texas averages 46.7 inches per year with peak rainfall typically occurring in the months of March and May (Figure 3.1).

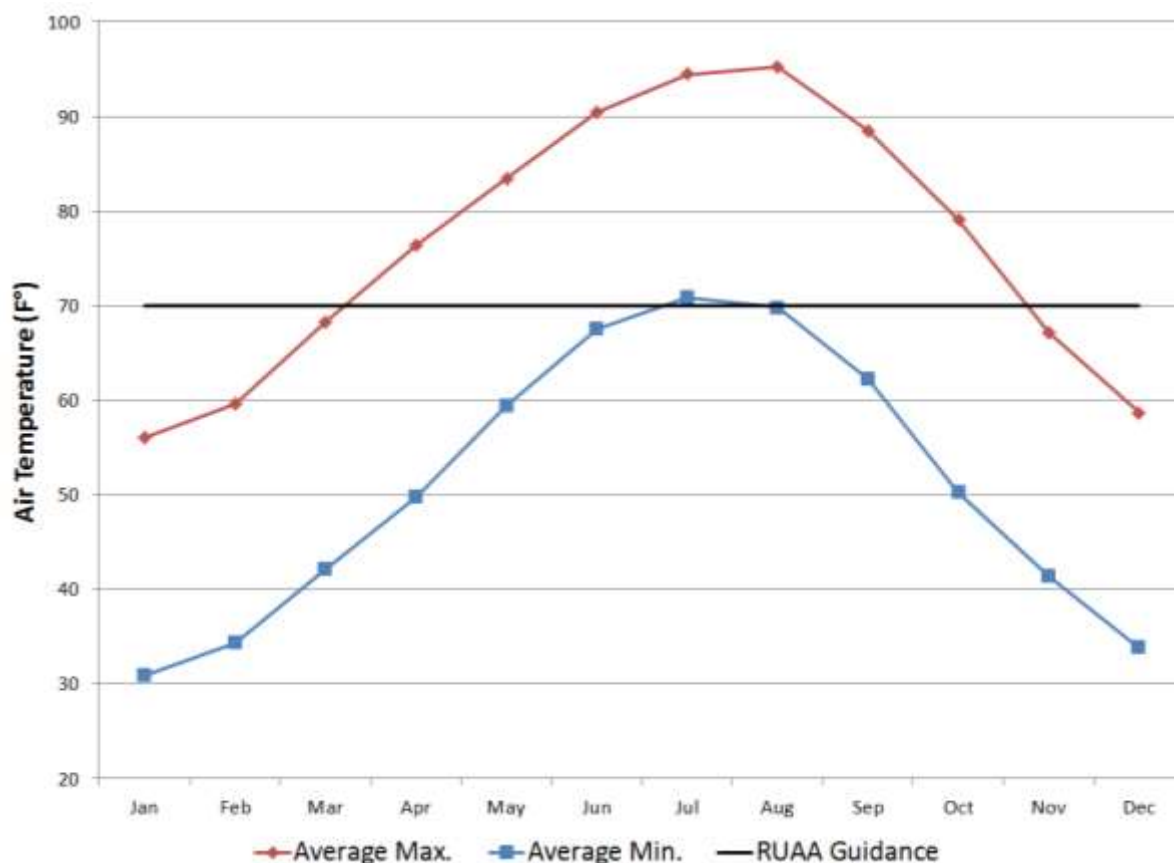
**Figure 3.2** Monthly average maximum and minimum air temperatures for Pittsburg, Texas compared to RUAA guidance for field surveys.

Source: NOAA (2015) based on data for 1974-2015 and TCEQ (2014).

Average maximum temperatures for Pittsburg, Texas rise above 70° F beginning in March and continue through October (Figure 3.2). March through October are the months noted as generally suitable for assessing recreational use, but only if temperatures reach above 70° F (TCEQ, 2014b).

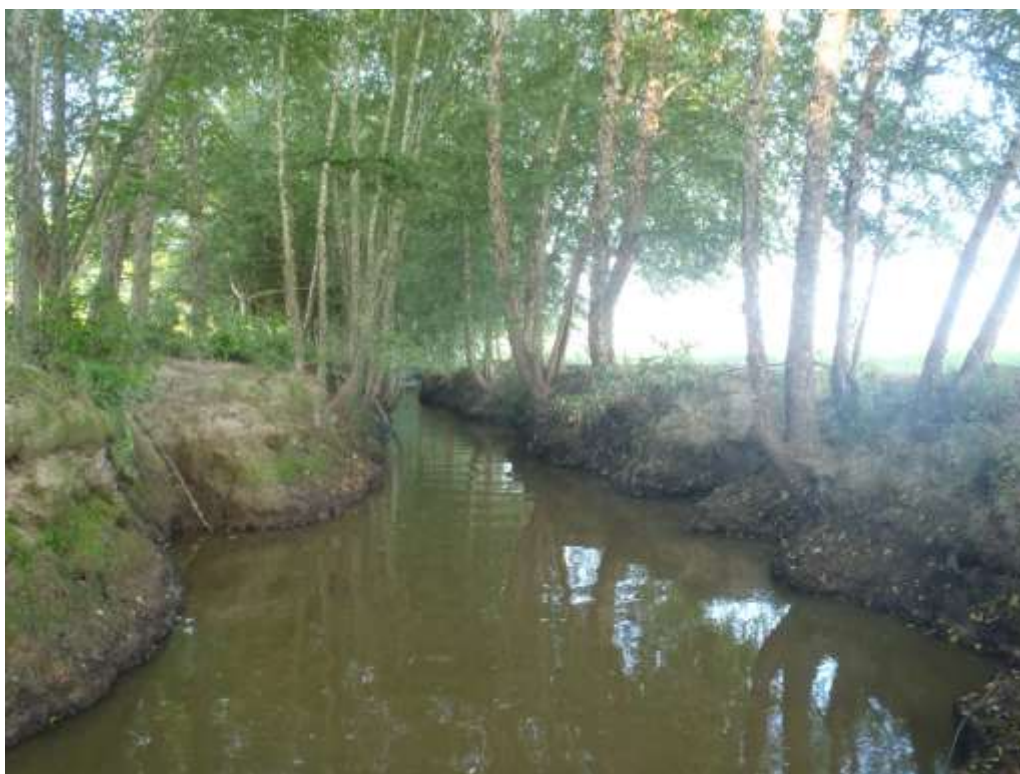
**Figure 4.2** Photograph of South Lilly Creek Site SL01 taken on June 21, 2016. The upstream view of the 300-m transect.

The creek at this site passes through improved pastures with native vegetation. The riparian area was small with trees and native pasture often leading directly up to the edge of the stream bank. Banks were steep and approximately 1 m high in places. Livestock trails leading into the creek existed occasionally along this stretch. The general appearance of the creek at this location is shown in Figures 4.2 and 4.3.

Site SL01 was wadeable with average thalweg ranging from 0.50 m to 0.40 m between surveys. Figure 4.2 illustrates the typical observed width of the creek at this site, approximately 3.5 m. Widths ranged from 7.0 m to 1.5 m during the two surveys (Tables 4.6 and 4.7).

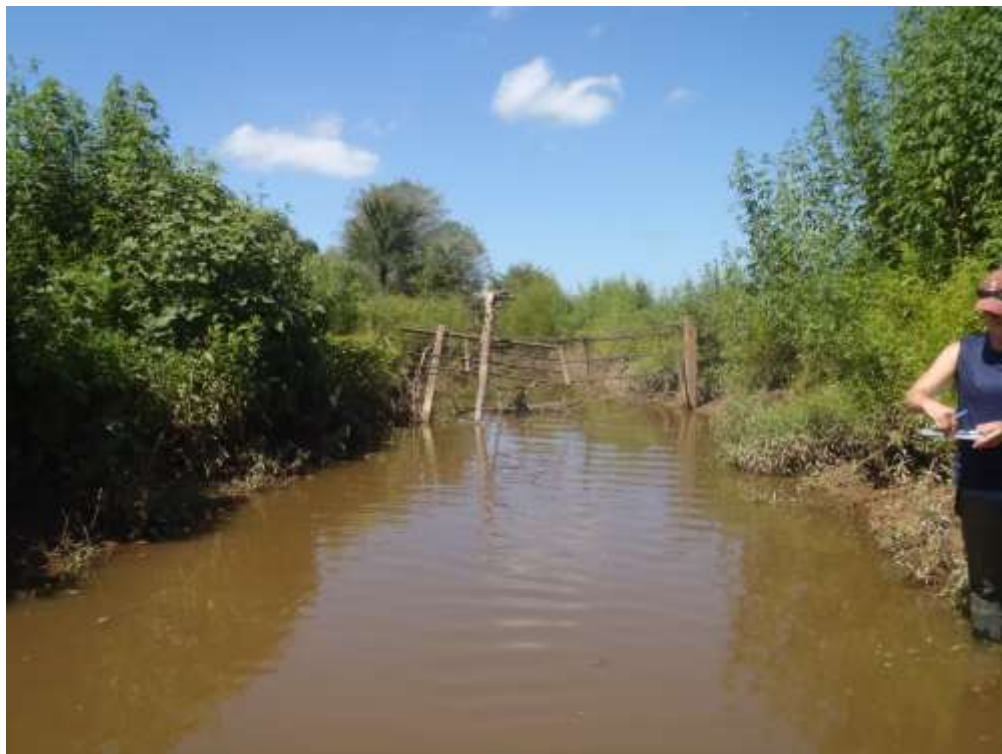
**Figure 4.3** Photograph of South Lilly Creek Site SL01 taken on August 24, 2016. The upstream view of the 0-m transect. TIAER personnel in photo.

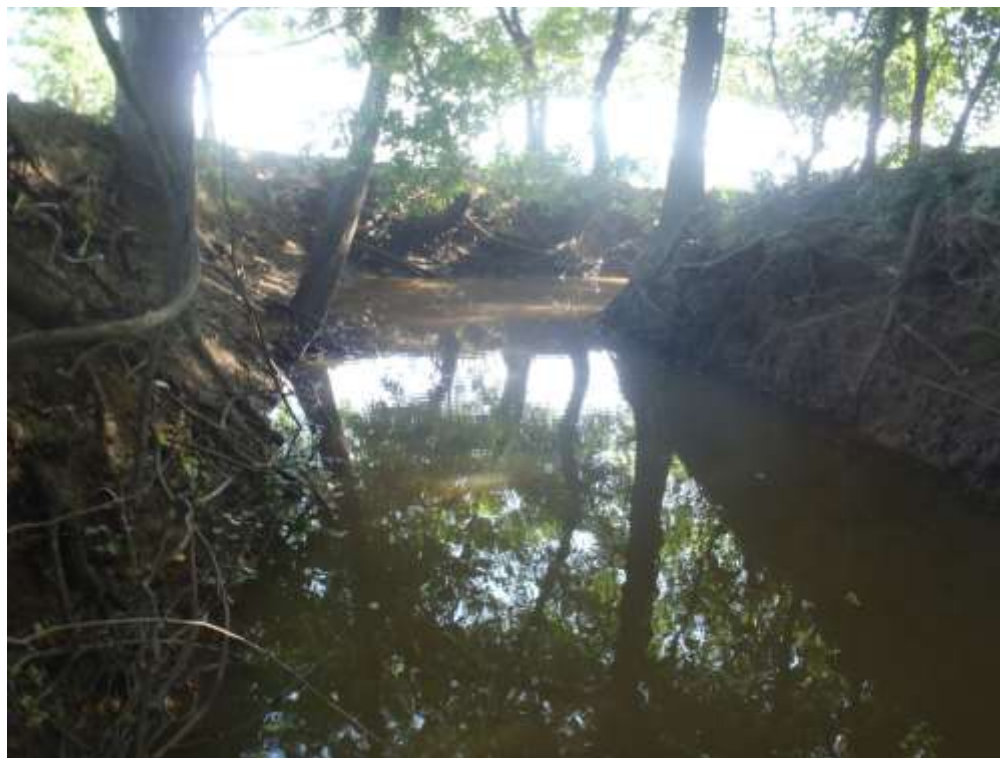
**Figure 4.4** Photograph of South Lilly Creek Site SL02 taken on June 21, 2016. Photograph shows the downstream view of the 300-m transect.

Similar to SL01, the stream at SL02 also passed through open pasture land with a small riparian area (Table 4.4). However the banks were vegetated with larger trees and a larger shaded understory (Figure 4.4). While some depths allowed for wading, non-wadeable depths were encountered during both surveys. Because the banks were relatively clear of dense vegetation, TIAER personnel were able to take measurements, photos and observations from the top of the banks at non-wadeable transects. Average thalweg depths ranged from 1.3 m to 0.93 m between surveys, and the stream flow type was characterized as perennial during both surveys (Table 4.5). The banks at this site were mostly vertical. Although thalweg depths generally decreased from the first survey to the second, the channel width remained the same throughout the reach during both surveys. Channel widths ranged from 14 m to 1.6 m across both surveys with a typical observed width of 2.6 m (Tables 4.6 and 4.7).

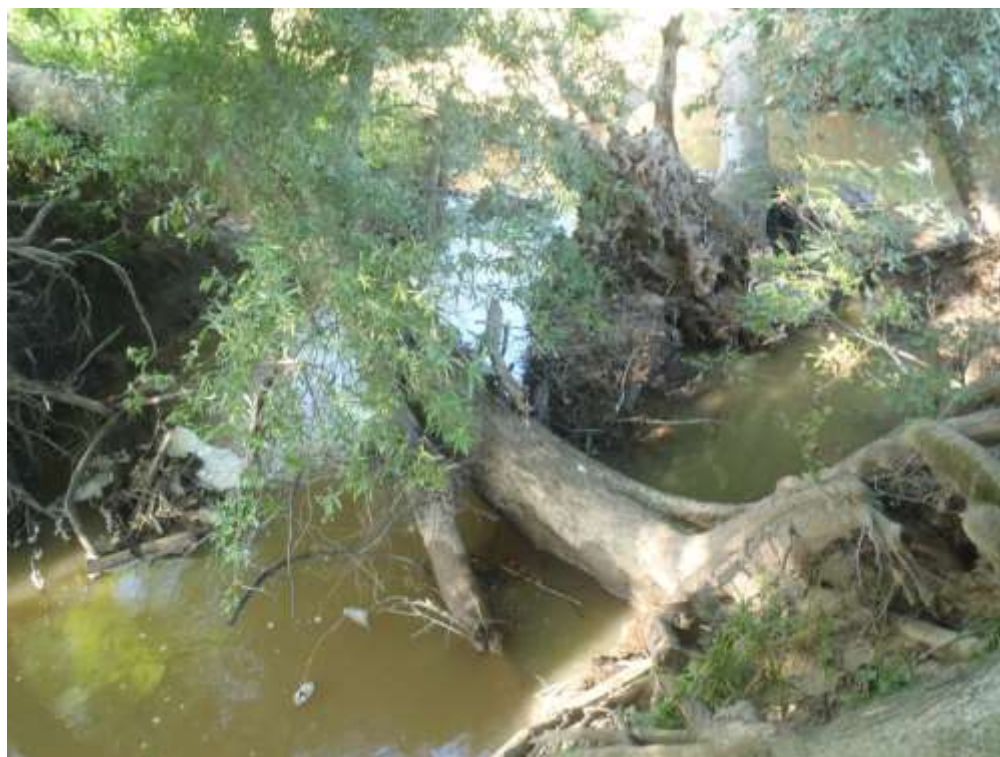
**Figure 4.5**      **Photograph of South Lilly Creek Site SL02 taken on June 21, 2016. Photograph shows a logjam between the 150-m and 300-m transect.**

One log obstruction was observed during both surveys between the 150-m and 300-m transect as shown in Figure 4.5.

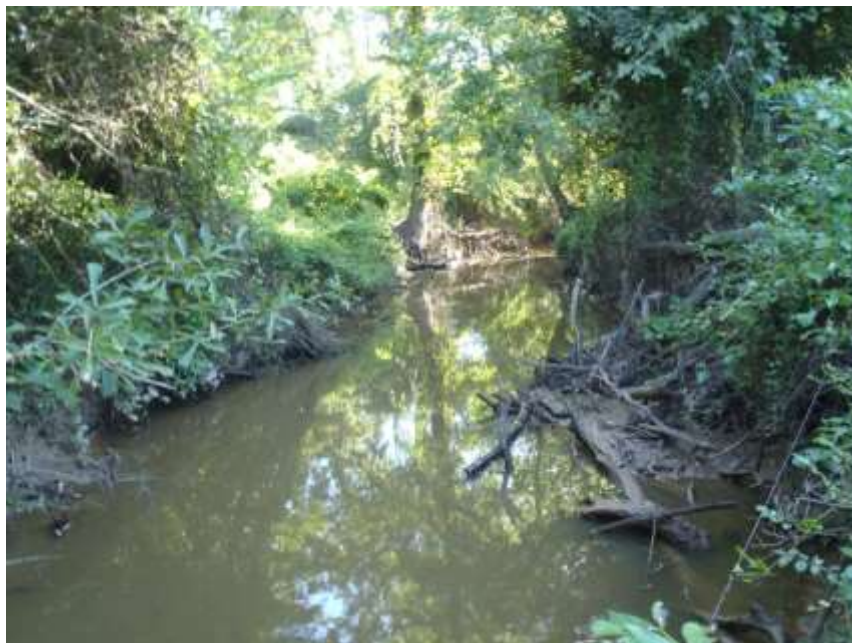
**Figure 4.6** Photograph of South Lilly Creek Site SL03 taken on August 24, 2016, the downstream view of the 0-m transect.

The stream banks were densely vegetated (as seen in Figure 4.6) at SL03. Logs, downed trees, smaller limbs, and twig debris (floating and submerged) were common in the channel. Aquatic vegetation and algae cover were absent during the first survey and observed rarely during the second survey. No odor was encountered and the color of the water was brown during both surveys. The surface of the water was clear during the first survey, while foam and scum were encountered at some locations along the 300 m reach during the second survey.

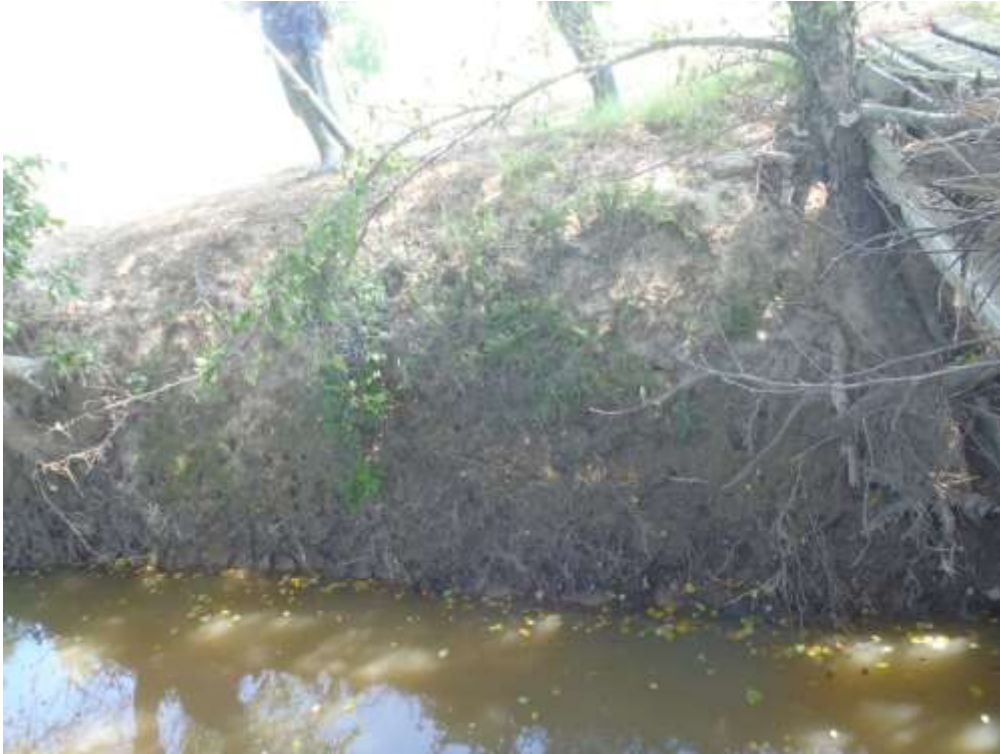
**Figure 4.8**      **Photograph of South Lilly Creek Site SL04 taken on June 21, 2016, the left bank view of the 150-m transect.**

South Lilly Creek at Site SL04 was visited on June 21 and August 24, 2016. This site was located on private property approximately 1.75 miles from FM 2455. Access to the site was granted by the landowner to the property leading to South Lilly Creek. TIAER personnel traveled by truck through a locked gate and continued through pastureland about 1.65 miles for the first survey before crossing over a fence and walking the remaining 0.10 miles to conduct the survey. Pastures through which South Lilly Creek runs were not navigable by vehicle after 4.6 inches of rain that fell within at least 10 days of the second survey. Therefore, during the second survey, TIAER personnel traveled by truck approximately 1.4 miles then walked the remaining approximate 0.35 miles to the site, also crossing the same fence as was done in the first survey. The riparian area associated with SL04 is small and is immediately bounded on both banks by improved pasture (Table 4.4). The general appearance of the creek at this location is shown in Figures 4.8 and 4.9.

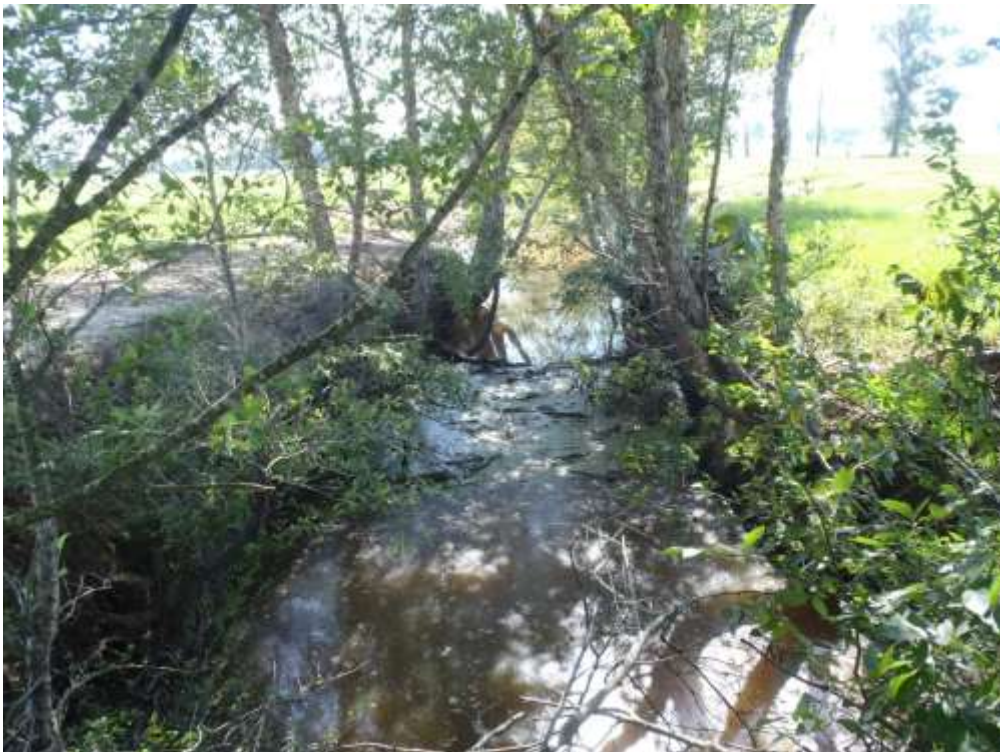
**Figure 4.9**      **Photograph of South Lilly Creek Site SL04 taken on August 24, 2016, the downstream view of the 150-m transect.**

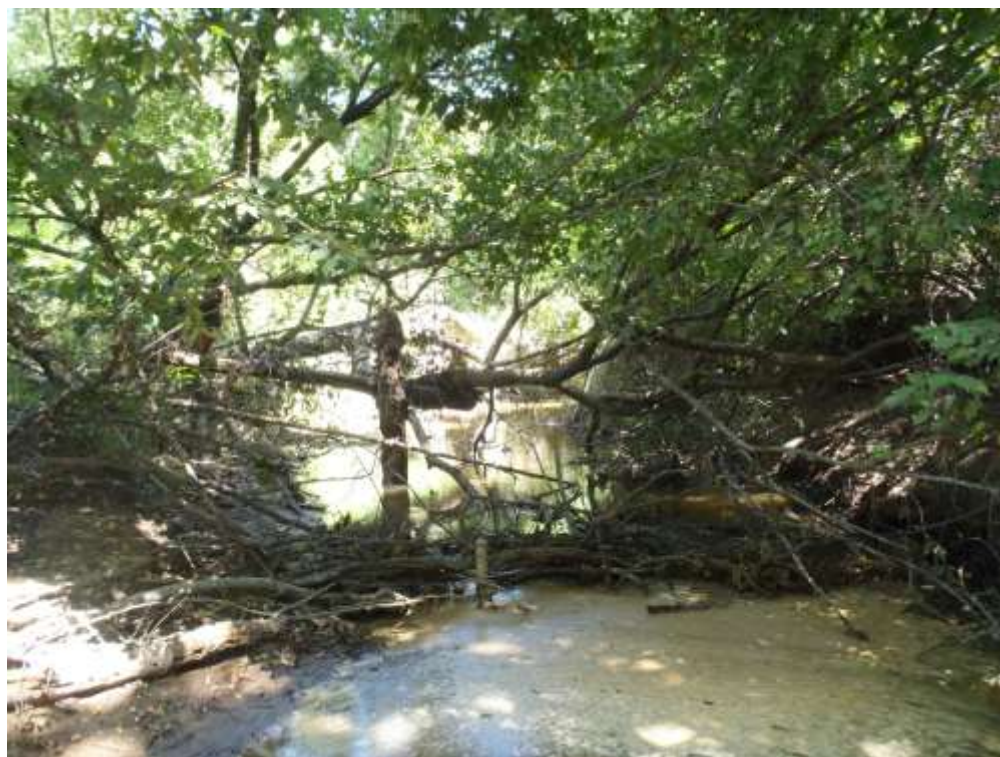
**Figure 4.10** Photograph of South Lilly Creek Site SL05 taken on August 24, 2016, the downstream view of the 120-m transect.

South Lilly Creek at Site SL05 was visited on June 21 and August 24, 2016. This site was located where the creek passes through a culvert pipe under Raccoon Road. Raccoon Road is a narrow, dirt road with insufficient room to park a vehicle completely off the road. Site SL05 was publicly accessible at the crossing but was fenced upstream and downstream of the crossing. The stream corridor consisted primarily of forest and shrubs with some pasture located along the right bank (Table 4.4). Access to the stream was difficult due to the vertical, 4-foot tall banks and dense vegetation (Table 4.5). The general appearance of the site during each survey is shown in Figures 4.10 and 4.11.

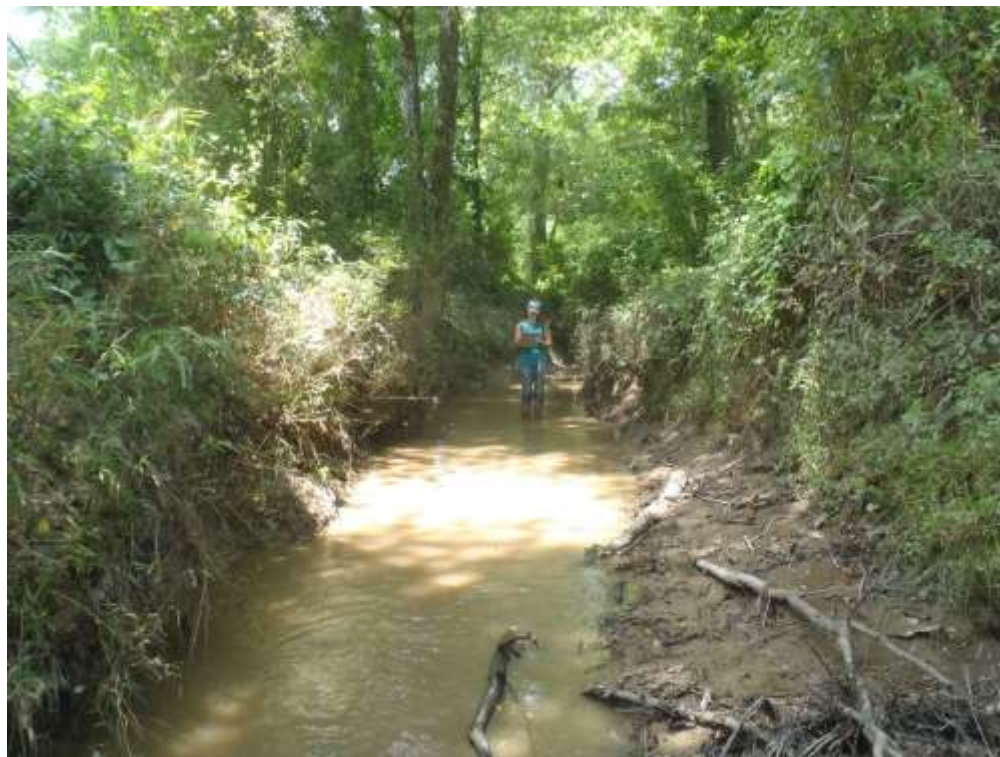
**Figure 4.11** Photograph of South Lilly Creek Site SL05 taken on June 21, 2016, the upstream view of the 150-m transect. TIAER personnel in photo.

During the second survey, which was started at the 300-m transect, a logjam was encountered at the 120-m transect (Figure 4.11). A water snake, encountered at this location, struck the boot of a TIAER field crew member. Additionally, a water moccasin was observed in the vicinity of the logjam and water snake. The banks were steep and densely vegetated, occasionally with poison

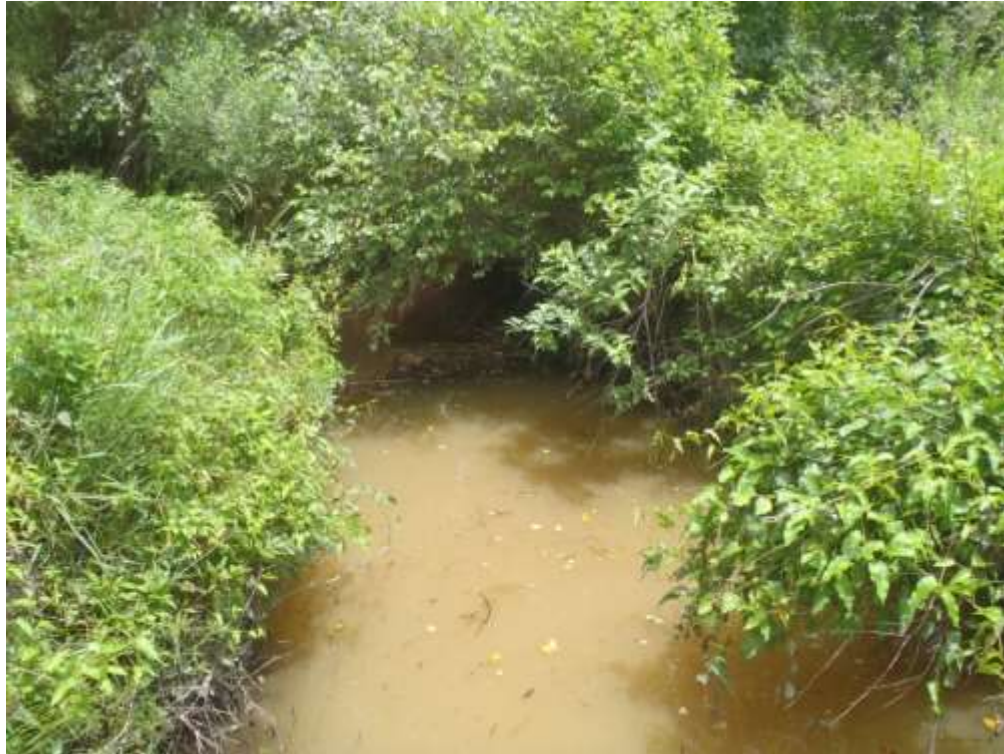
**Figure 4.12** Photograph of South Lilly Creek Site SL06 taken on June 21, 2016, the downstream view of the 150-m transect.

South Lilly Creek at Site SL06 was visited on June 21 and August 23, 2016. This site was located where the creek passes through a culvert pipe under Squirrel Road. Similar to Raccoon Road, Squirrel Road is a narrow dirt road with insufficient room to park a vehicle completely off the road. TIAER personnel parked about 0.10 mile up the road in a pasture entrance and walked to the creek. Site SL06 was publicly accessible at the road but was fenced upstream and downstream of the crossing. Lack of close parking and private property fencing perpendicular to the stream made access moderately difficult. With landowner permission, TIAER personnel crossed over the fence and continued to complete the survey upstream of the road. The stream corridor was narrow with a small riparian area consisting primarily of shrub and herbaceous vegetation with interspersed trees. Open pasture existed out beyond the brush on both banks (Table 4.4). Figures 4.12 and 4.13 depict the general appearance of the site during each of the surveys.

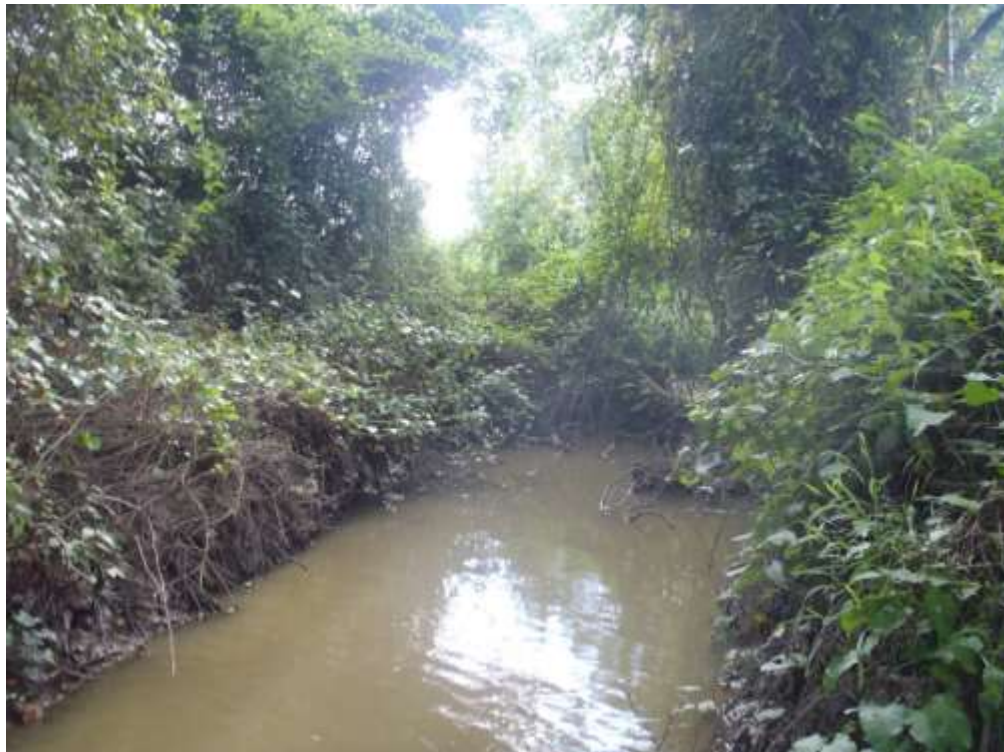
**Figure 4.13** Photograph of South Lilly Creek Site SL06 taken on August 23, 2016, the upstream view of the 300-m transect.

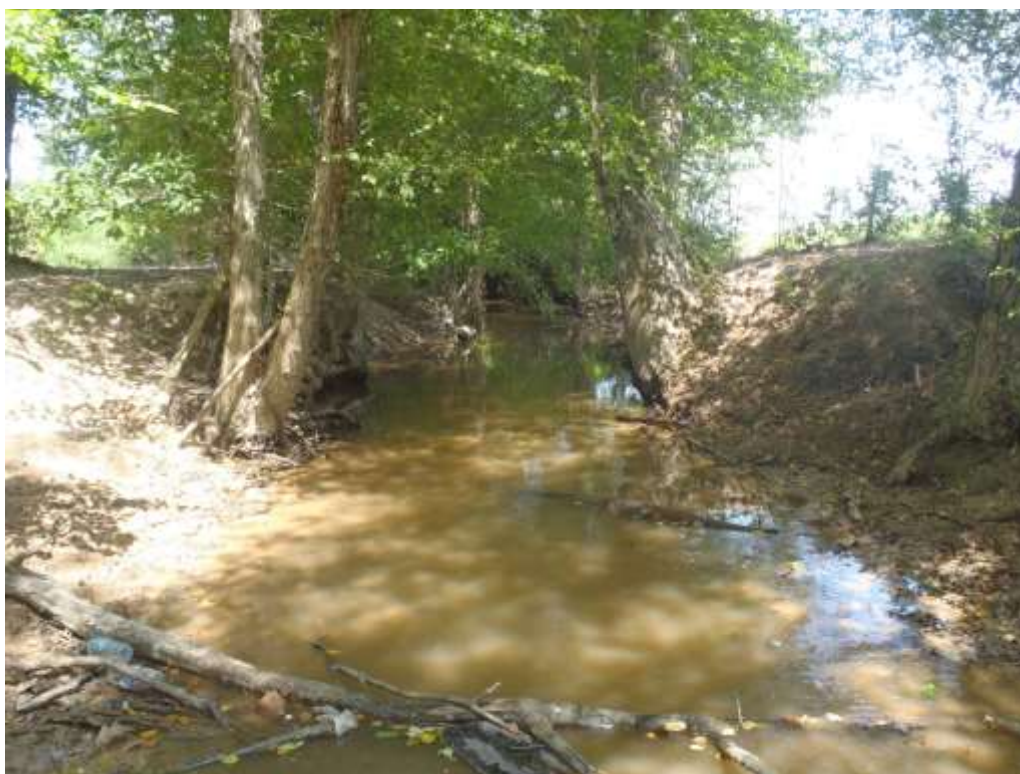
**Figure 4.14** Photograph of South Lilly Creek Site SL07 taken on June 21, 2016, the downstream view of the 300-m transect.

South Lilly Creek at Site SL07 was visited on June 21 and August 24, 2016. This site was located where the creek passes through a culvert pipe under Woodchuck Road. Similar to other roads in the area, Woodchuck Road is narrow with insufficient space to park a vehicle completely off the road. Site SL07 was publicly accessible at the crossing but was fenced upstream and downstream of the crossing. Private property fencing perpendicular to the stream made access difficult. With landowner permission, TIAER personnel crossed over the fence and continued to complete the survey downstream of the road crossing. The stream corridor was narrow with a small riparian area consisting primarily of shrub and herbaceous vegetation with interspersed trees (Table 4.4). Pastureland existed beyond the corridor on the right bank, while the left banks were primarily shrub land beyond the banks. Bank access was difficult due to densely vegetated banks and steep slopes. Logjams were encountered including one large one at the 180-m transect. Figures 4.14 and 4.15 depict the general appearance of the site during each of the surveys.

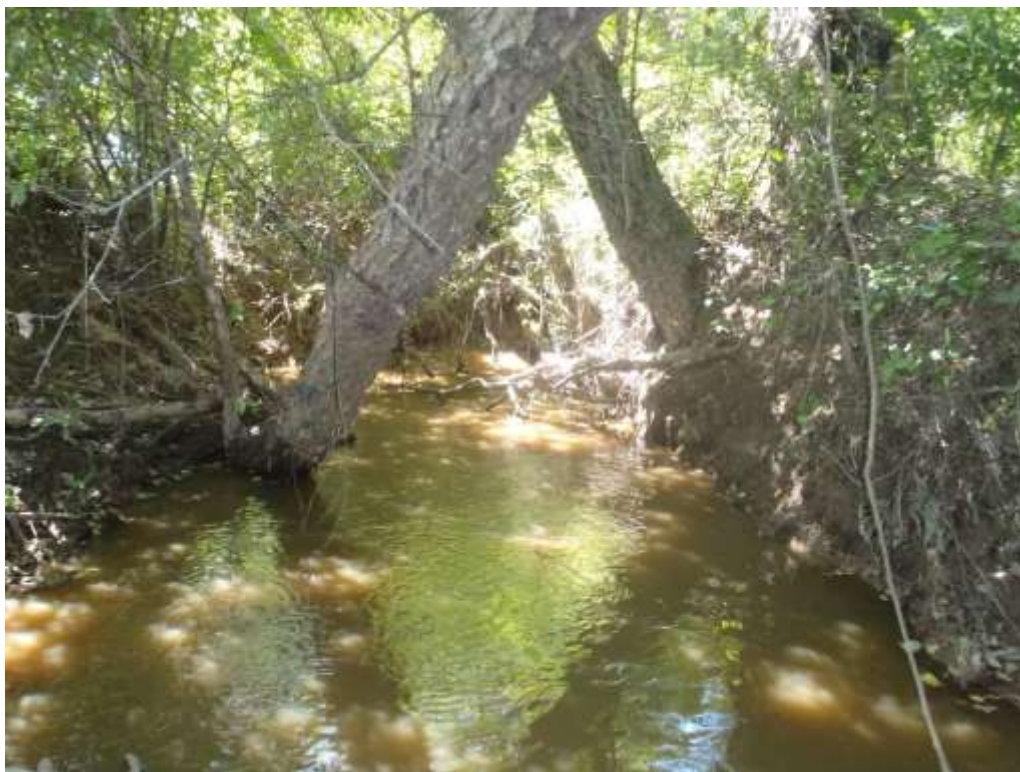
**Figure 4.15** Photograph of South Lilly Creek Site SL07 taken on August 24, 2016, the upstream view of the 150-m transect.

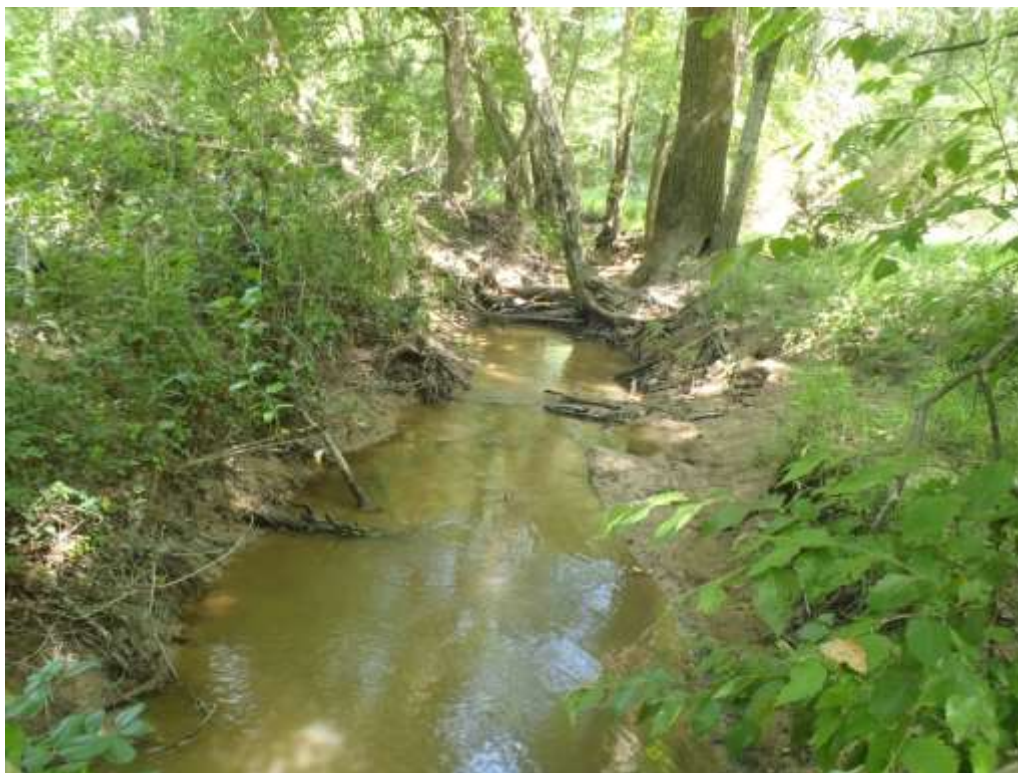
**Figure 4.16** Photograph of South Lilly Creek Site SL08 taken on June 21, 2016, the downstream view of the 0-m transect.

South Lilly Creek at Site SL08 was visited on June 21 and August 23, 2016. This site was located where the creek passes through a culvert pipe under Waterbuck Road. Access to this site was public at the road crossing. TIAER personnel entered the creek at the culvert pipe that passed under the road and completed the surveys downstream. A private property fence bisected the creek approximately 15 m downstream of the Waterbuck Road crossing. The riparian area was small at this site. Banks were approximately 0.5 m high on average making bank access moderately easy. In terms of vegetation, the stream corridor had an open understory with trees and shrubs scattered along the banks with a grassy ground cover meeting the edges of the banks. Poison ivy was present along the stream banks. Between 300 m and 250 m of this site, both banks were wooded. From the 250-m transect to the 0-m transect, the right bank opened up to pasture about 20 m from the stream while the left bank remained wooded. Figures 4.16 and 4.17 depict the general appearance of the site during each of the surveys.

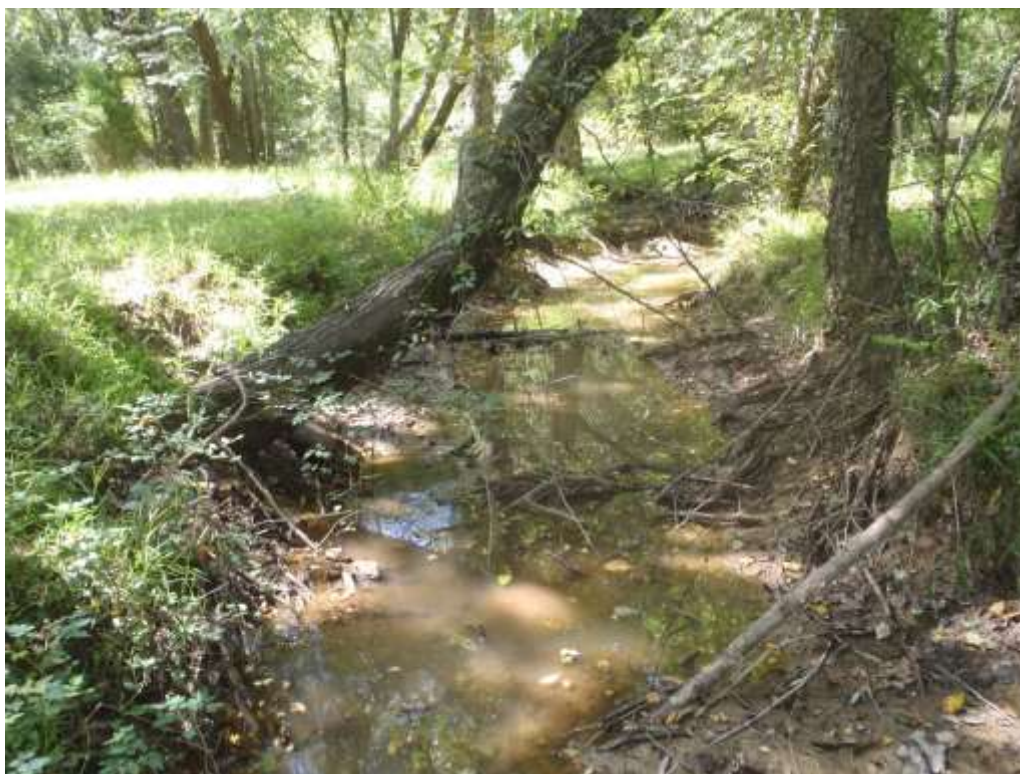
**Figure 4.17** Photograph of South Lilly Creek Site SL08 taken on August 23, 2016, the upstream view of the 0-m transect.

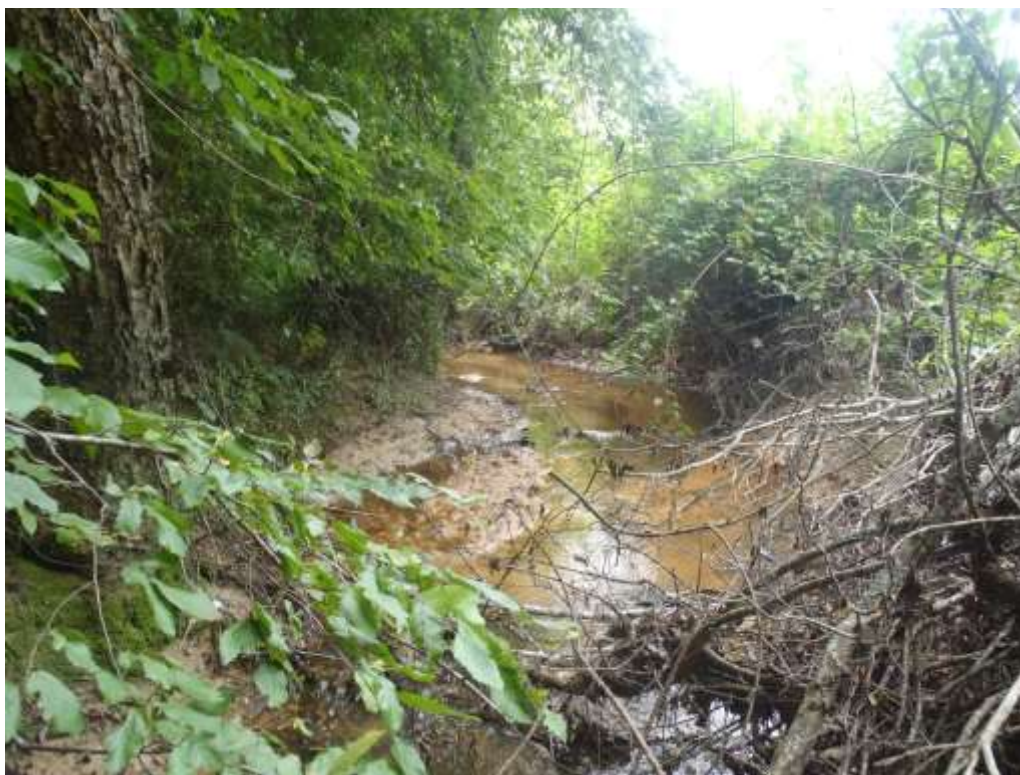
**Figure 4.18** Photograph of South Lilly Creek Site SL09 taken on June 20, 2016, the upstream view of the 150-m transect.

South Lilly Creek at site SL09 was visited June 20, 2016 and August 23, 2016. This site was located at the crossing of South Lilly creek at FM 1647. While FM 1647 is a paved road, it lacks sufficient shoulder space for safe parking. TIAER personnel were required to park up the road at a pasture entrance and walk to the site during the first survey because the ditches along the road were too wet nearer the creek. Drier conditions during the second survey allowed TIAER personnel to park in the bar ditch next to the creek. The stream riparian corridor was small but ran through forest vegetation with dense herbaceous understory (Table 4.4). An overgrown fencerow existed approximately 10 m from the creek on the left bank and a path between the two had recently been cleared upon conducting the first survey. This was the only non-forested area adjacent to this site. Access to this site was easy due to its proximity to a public road and gently sloping banks leading from the bar ditch to the water. There also were no cross fences up or downstream of the road crossing restricting access. Bank vegetation away from the road crossing closed in quickly making access up and out of the channel difficult to impossible. Figures 4.18 and 4.19 depict the general appearance of the site during each of the surveys.

This site was wadeable during both surveys with average thalweg depths of 0.21 m during the first survey and 0.24 m during the second survey, and stream flow type was considered intermittent during both surveys (Table 4.5). Widths were unchanging between the first and second surveys with a maximum width of 2.0 m, minimum width of 0.1 m, and a typical average width of 1.5 m (Table 4.7). Aquatic vegetation was rare and algae cover was absent during both surveys. The

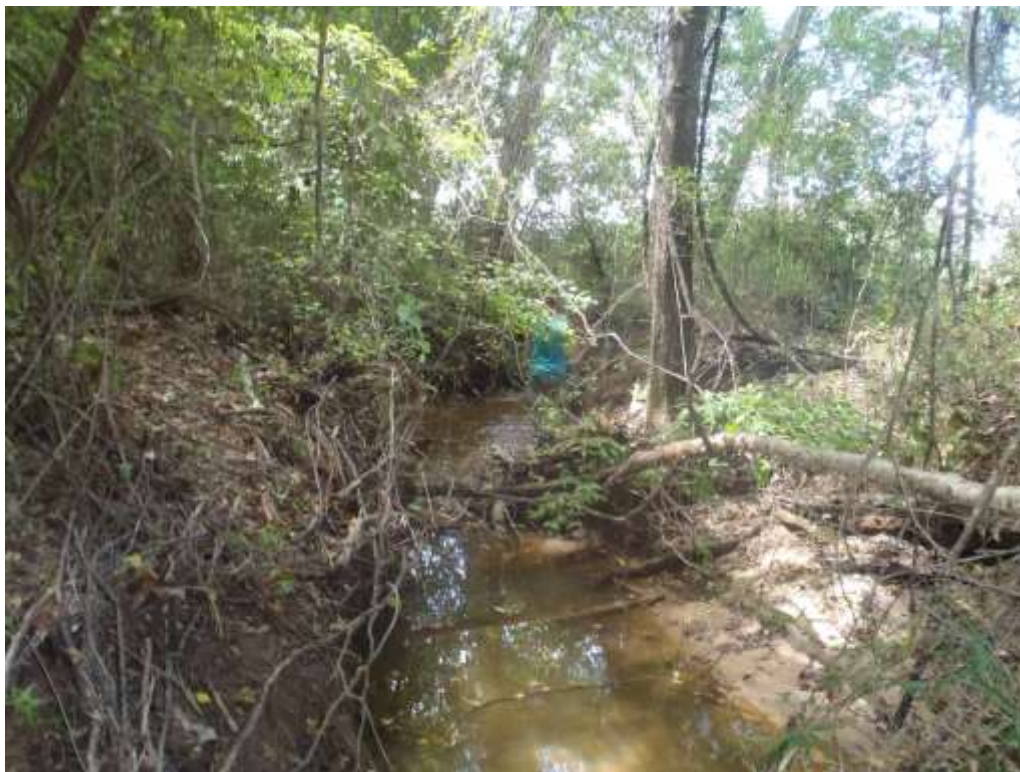
**Figure 4.19** Photograph of South Lilly Creek Site SL09 taken on August 23, 2016, the upstream view of the 0-m transect. TIAER personnel in photo.
